CONCLUSIONS: Primary Property Assessment

Roof Rejuvenate USA
 Rejuvenator Shingle
 Rejuvenator Study July 6,
 2023 Page 7 of 13

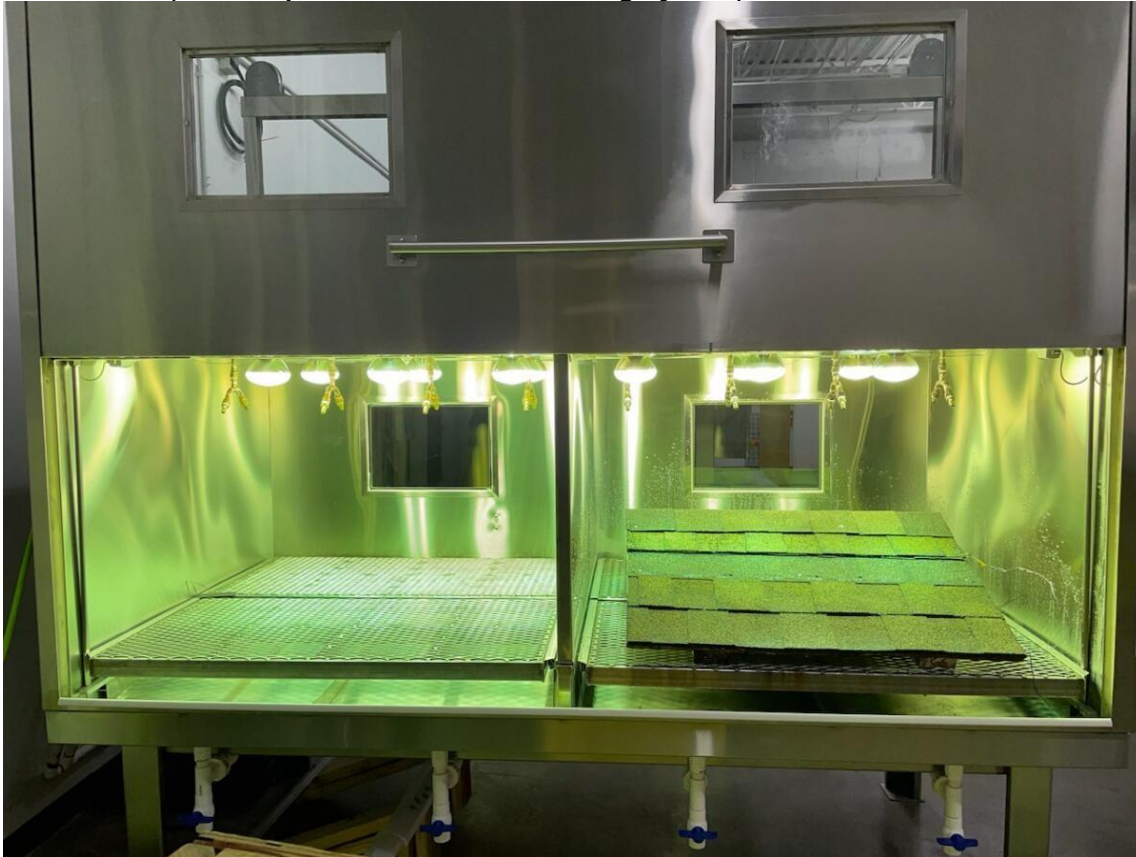
APPENDIX A-3 (PRI – Asphalt Pavement Weathering System):

An open view of PRI's Asphalt Pavement Weathering System with the roof deck positioned in the front chamber (right).

PRI's APWS was used for accelerated weathering of the roof deck after the application and curing of the rejuvenators. The weatherometer is monitored daily for even light distribution and water spray coverage, while temperature of the chamber, roof surface, water, ambient temperature and relative humidity are all tracked continuously.

PARAMETER	SETTING
<i>APWS Cycle and Climate Information</i>	
Cycle Reference Method	ASTM D4798, Cycle A
Time of UV Light Exposure, mins	51
Time of UV Exposure with Rain Cycle, mins	9
Average Maximum Shingle Temperature, °F (Note 1)	149.5
Average "Rain Rate", gal/hr	12.6

Note 1 – Average Maximum Shingle Temperature is measured by taking the average of the temperature readings immediately before the beginning of the "rain cycle" when the temperature is at its highest level.

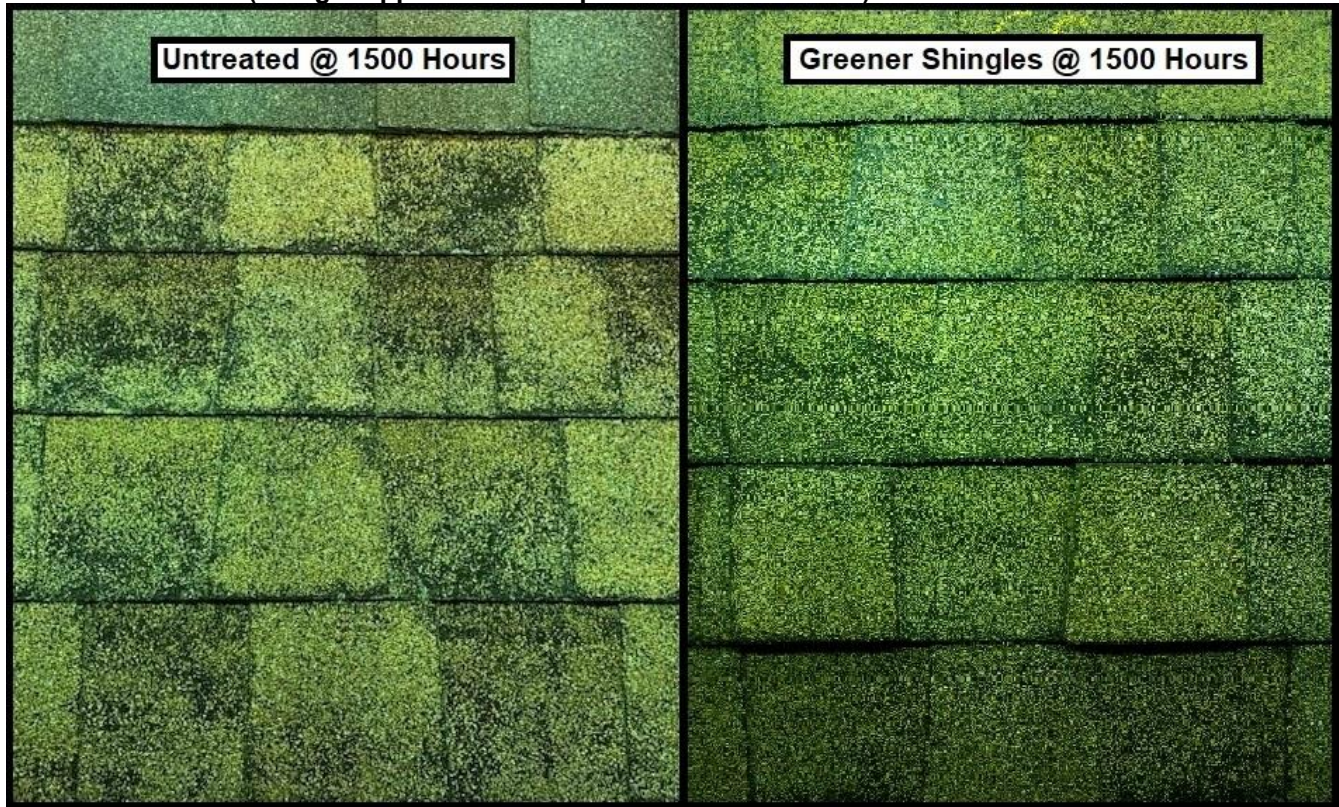
APPENDIX A-4 (Shingle Appearance Comparison – ~1500 hours):

There is a notable difference in appearance between the untreated and treated shingles after 1500 Hours.

- **Shingle Flexibility:** After 1,500 hours of exposure, 5RRI5HMDWH86 Rejuvenator improved low temperature flexibility from -22°F to -31°F.
- **Shingle Color and Appearance:** After 1,500 hours of exposure, the shingles treated with 5RRI5HMDWH86 Rejuvenator exhibit a significantly different appearance than those left untreated.

- Un-treated shingles show a clear increase in the roofing granules lost. (Appendix A-4)

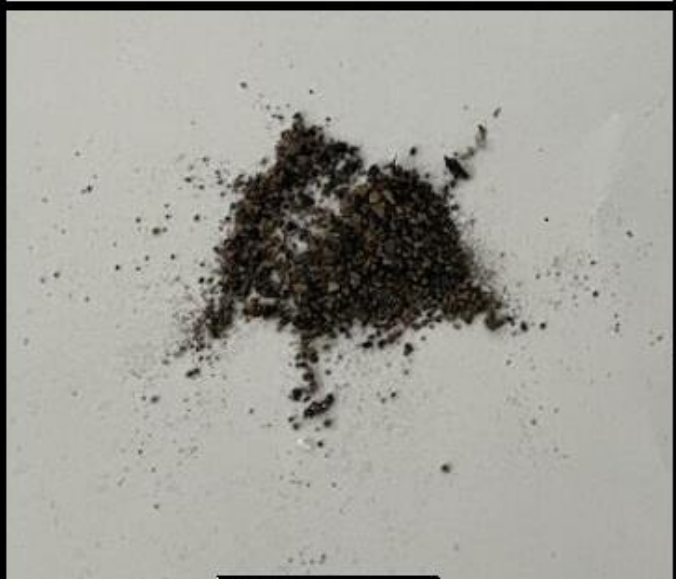
<p data-bbox="363 1081 581 1136">0.70 grams</p>

Granules and particulate washed from the roof decks after 1500 hours of exposure. Particles have been filtered from the accompanying runoff water and dried for quantification.

- After 1,500 hours of exposure the mass of the collected particulate from the un-treated shingles was 4.08g compared to 0.70g for the Roof Rejuvenate USA' rejuvenator.
